PERFORMANCE OF RECYCLED ASPHALT SHINGLES FOR ROAD APPLICATIONS

Final Report

September 2002

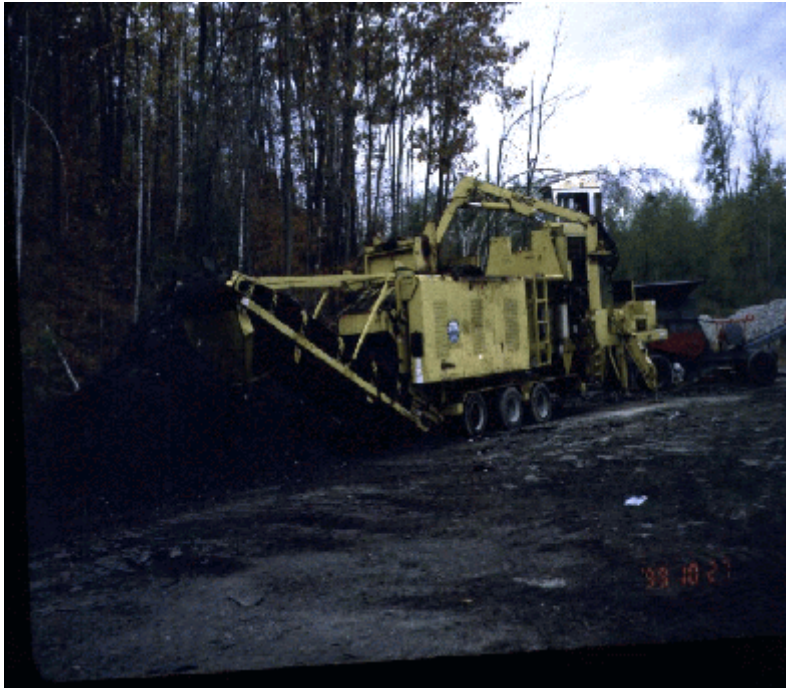
Chittenden Solid Waste District's grinder processing some of the 394 tons of waste asphalt shingles collected from April 1999 to July 2000.

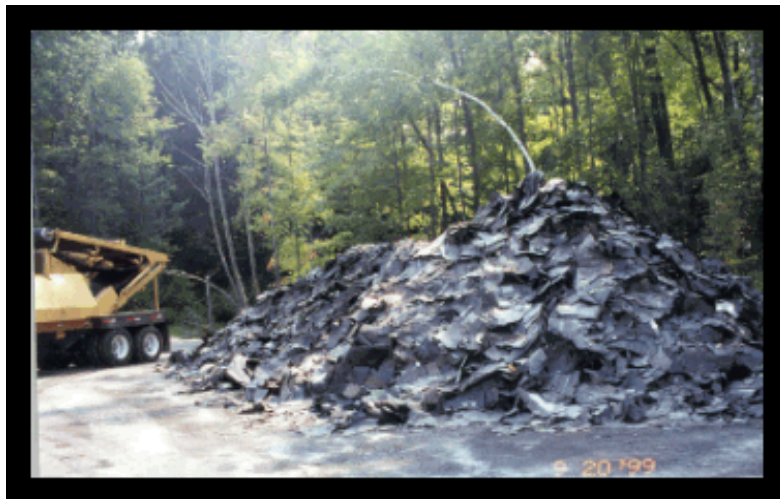
Stockpiled asphalt shingles at A. Marcelino and Company, South Burlington.

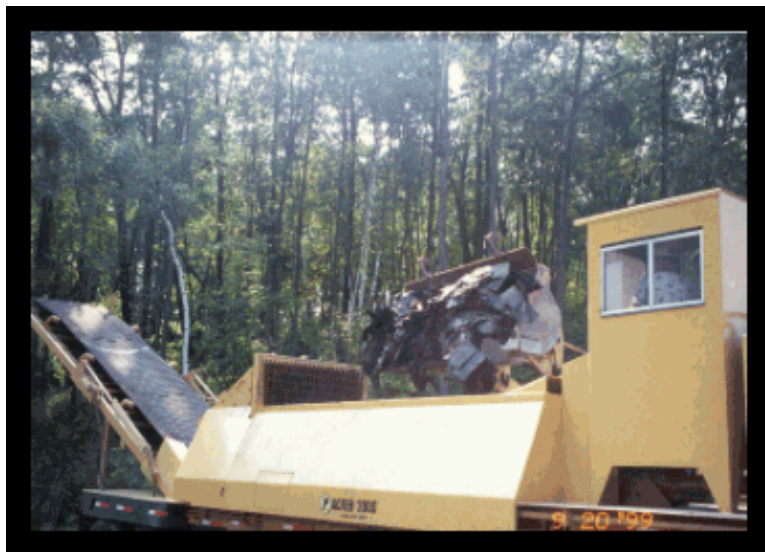
Packer Industries demonstrating their rotary drum grinder on collected asphalt shingles at A. Marcellino

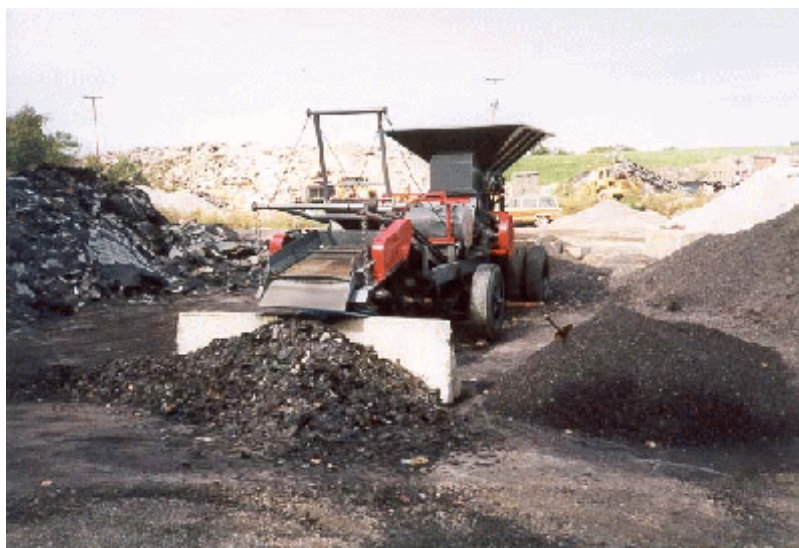
A Marcellino shingle processing equipment, South Burlington.

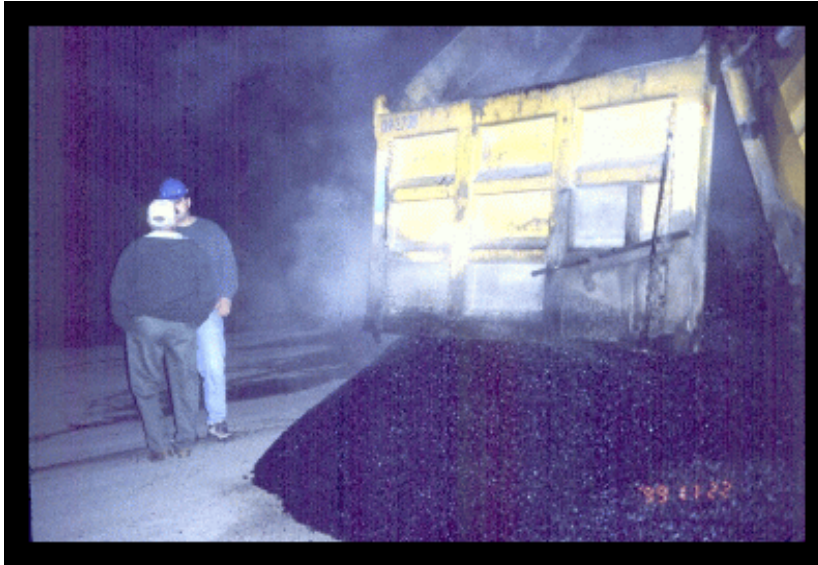
Newly manufactured recycled asphalt shingle (RAS) cold patch at Pike Industries, Williston, Vermont

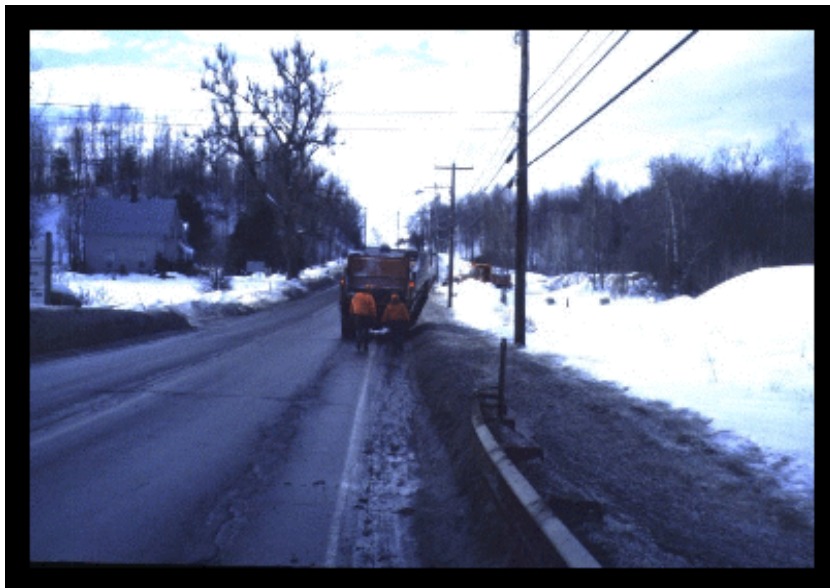
2/22/00

VTrans trial location for RAS cold patch, VT 14, South Barre, VT

The results from the cold patch have been mixed, and at times even contradictory. Barre has found the material to work very well, have long sticking power, and be easy to use. In contrast, the VAOT District 6 has found the material too stiff to work with and of low quality and stopped using it in mid February.

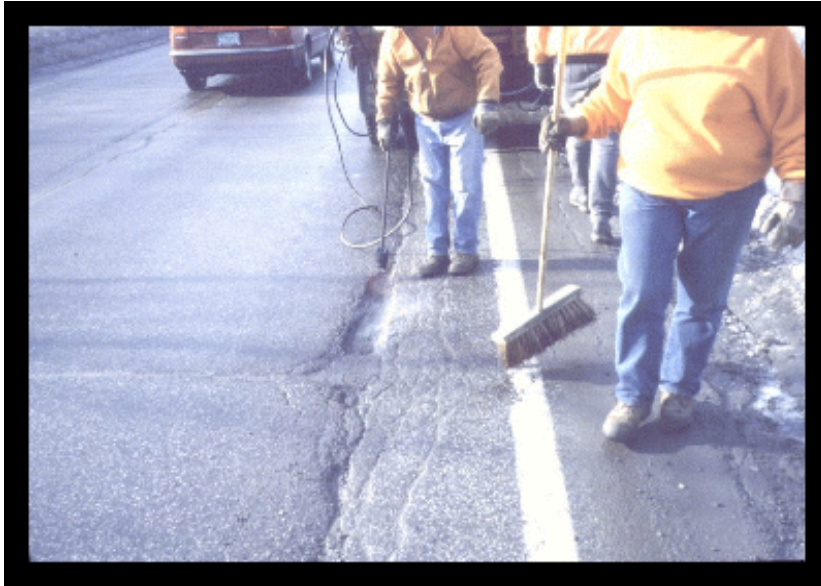
Drying potholes prior to cold patching. VT 14, South Barre

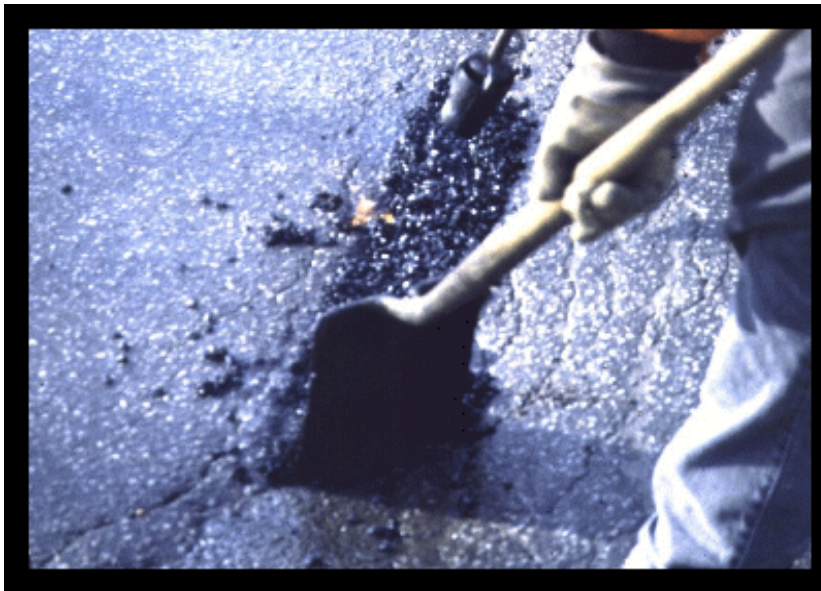
Pothole filling with cold patch, VT 14, South Barre.

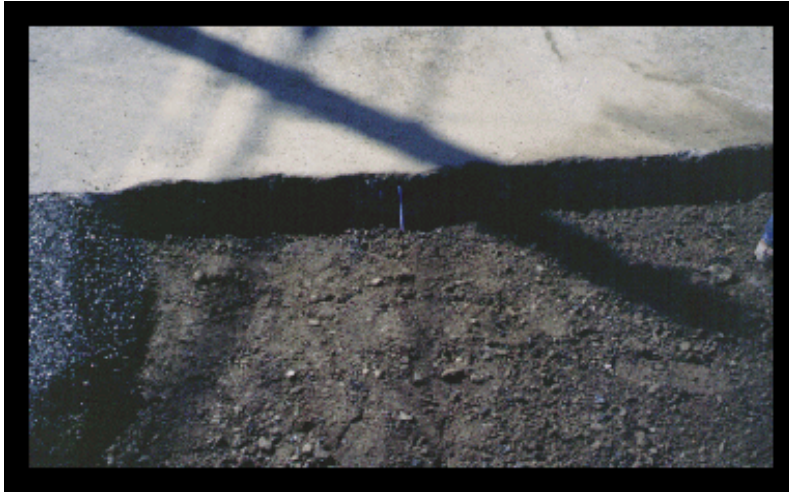
VTrans culvert repair, VT 109, Waterville. Northbound lane of road paved with conventional cold patch (complete, to the left) and southbound lane (shown prepared for paving) paved with RAS cold

patch.

For a basis of comparison, the strategy was to repave one traveling lane with conventional QPR cold patch, and repave the other travel lane with the RAS cold patch. The conventional cold patch was placed first, on the northbound lane. First, the upper 5" of soil was removed, and the edges cleaned, of the area to be paved. Then the estimated amount of cold patch material needed for a first (3") lift was dumped from the truck, roughly spread with a backhoe, then smoothed with shovels and rakes. Finally, the VAOT truck was then driven over the loose cold patch to compact it. The dumping, smoothing, rolling process was repeated for the finished grade.

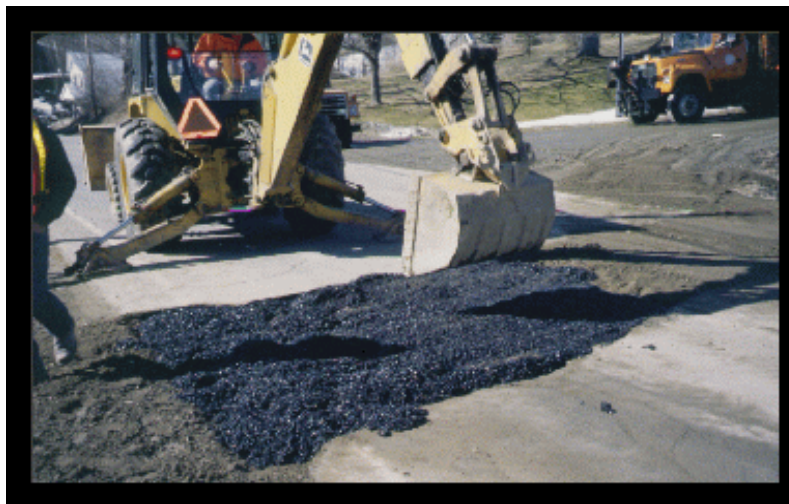
Culvert repair, VT 109, Waterville. Spreading conventional cold patch with backhoe

The conventional cold patch had a very loose, pliable consistency. The pile that was dumped from the truck onto the road tended to slump and spread outward. The material appeared quite "wet". The crew foreman, "Mark", characterized the cold patch as somewhat "self-leveling", and indeed it appeared to be. The material contained no appreciable clumps, and was easily worked with hand tools. The finished surface was quite smooth and level after having been rolled by the dump truck, and passing traffic did not seem disturbed while traveling over the patch.

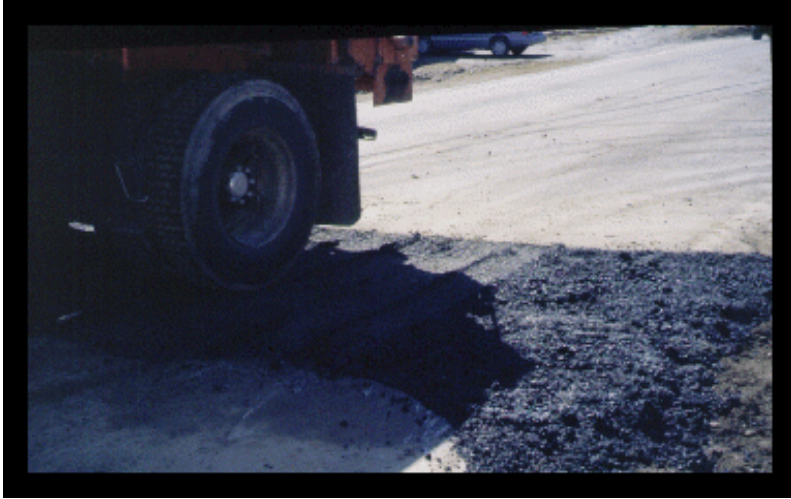
Culvert repair, VT 109, Waterville.
Compacting RAS cold patch with
dump truck.

In conclusion, the conventional cold patch is more easily applied because of its pliable, more liquid, consistency. The RAS cold patch was dryer and harder, which resulted in difficulty machine- and hand- working the pavement. The VAOT crew expressed deep concerns about using the RAS pavement on smaller, shallow repairs, such as a typical pothole. Even in this application, there were concerns about long term cracking and loss of adhesion.

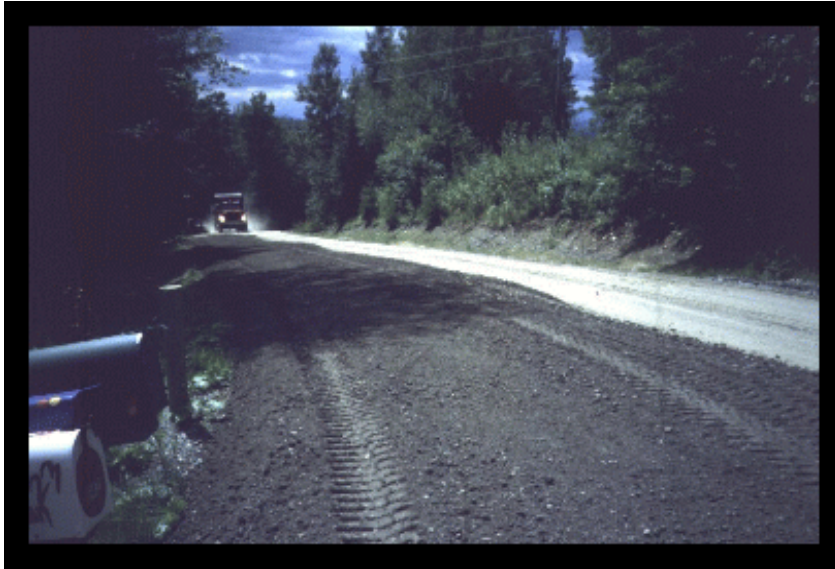
VTrans culvert repair, VT 109 Waterville. Completed cold patch paving. Conventional cold patch in background, RAS cold patch in foreground.

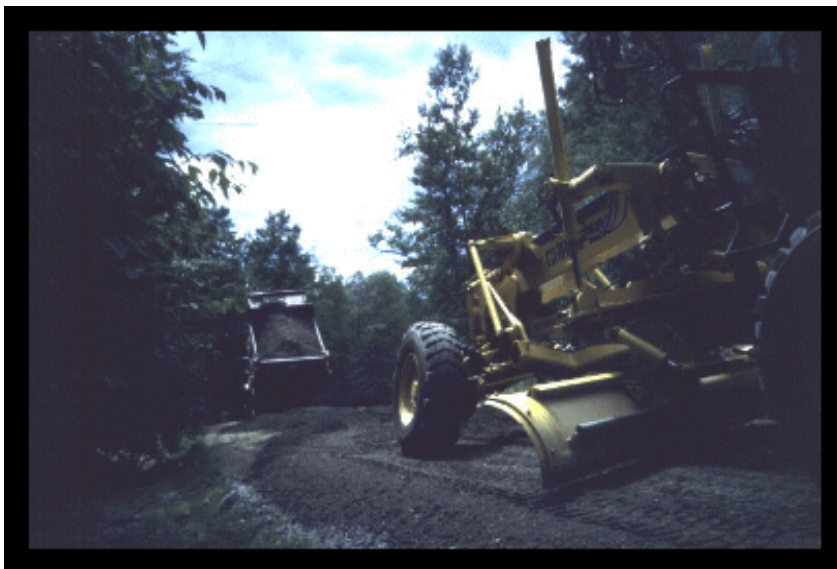
Placement of a lift of
RAS/RAP/gravel on Texas Hill
Road, TH17, Hinesburg. A

total of 524 tons were placed over 0.17 miles.

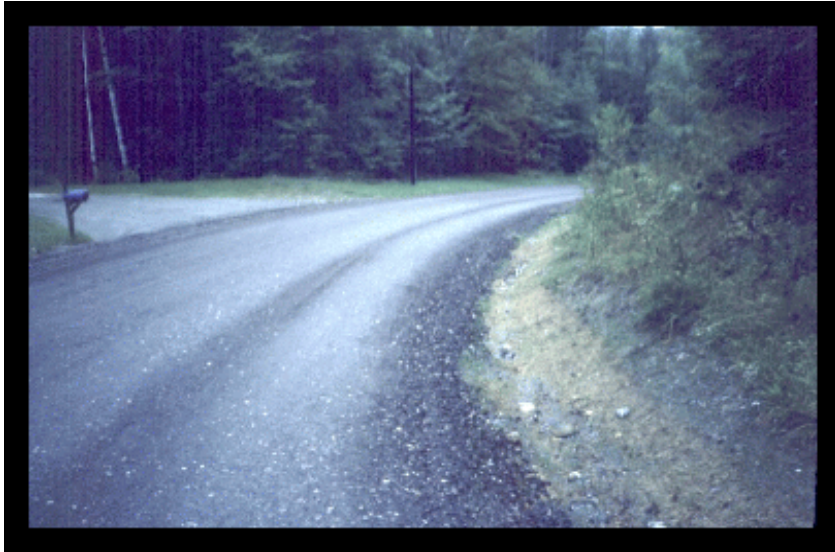
Placement of RAS/RAP/gravel
on Texas Hill Road, TH17,
Hinesburg. A total of 524 tons
were placed over 0.17 miles.

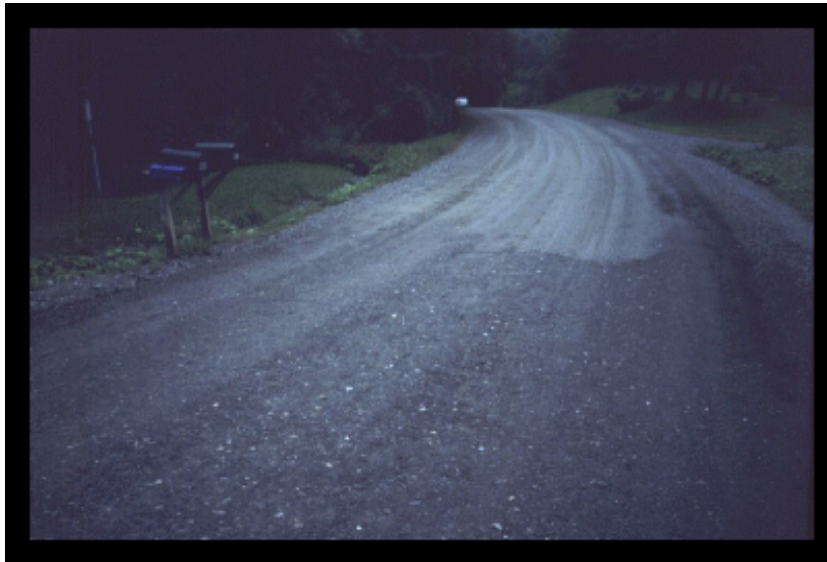
Completed section of TH 17, Hinesburg, RAS/RAP/gravel. Material was placed in (2) 3" lifts, compacted, and sprayed with calcium chloride.

In late October 2000, the road surface was developing washboards from the heavy traffic. According to Hinesburg Road Foreman Mike Anthony, the Town decided to grade the road, but the first grading actually made it rougher. The second grading was done in the rain and the road was very smooth and the material packed well without being rolled. This scenario was corroborated by Nancy Plunkett, Waste Reduction Manager with the CSWD, who lives on Texas Hill Road.

The road has remained in good condition through June 2002, developing fewer potholes and necessitating less frequent grading than the control section.
